"EAGLE," (S.S.)

In the matter of the formal Investigation held at the Guildhall, Swansea, on the 22nd and 23rd August 1879, before H. C. ROTHERY, Esquire, Wreck Commissioner, assisted by R. C. MAY, Esq., C.E., and Captain BEASLEY, as Assessors, into the circumstances attending the abandonment and loss of the British steamship "EAGLE," of Swansea, on the 29th July last, whilst on a voyage from Swansea to Dublin.

Report of Court.

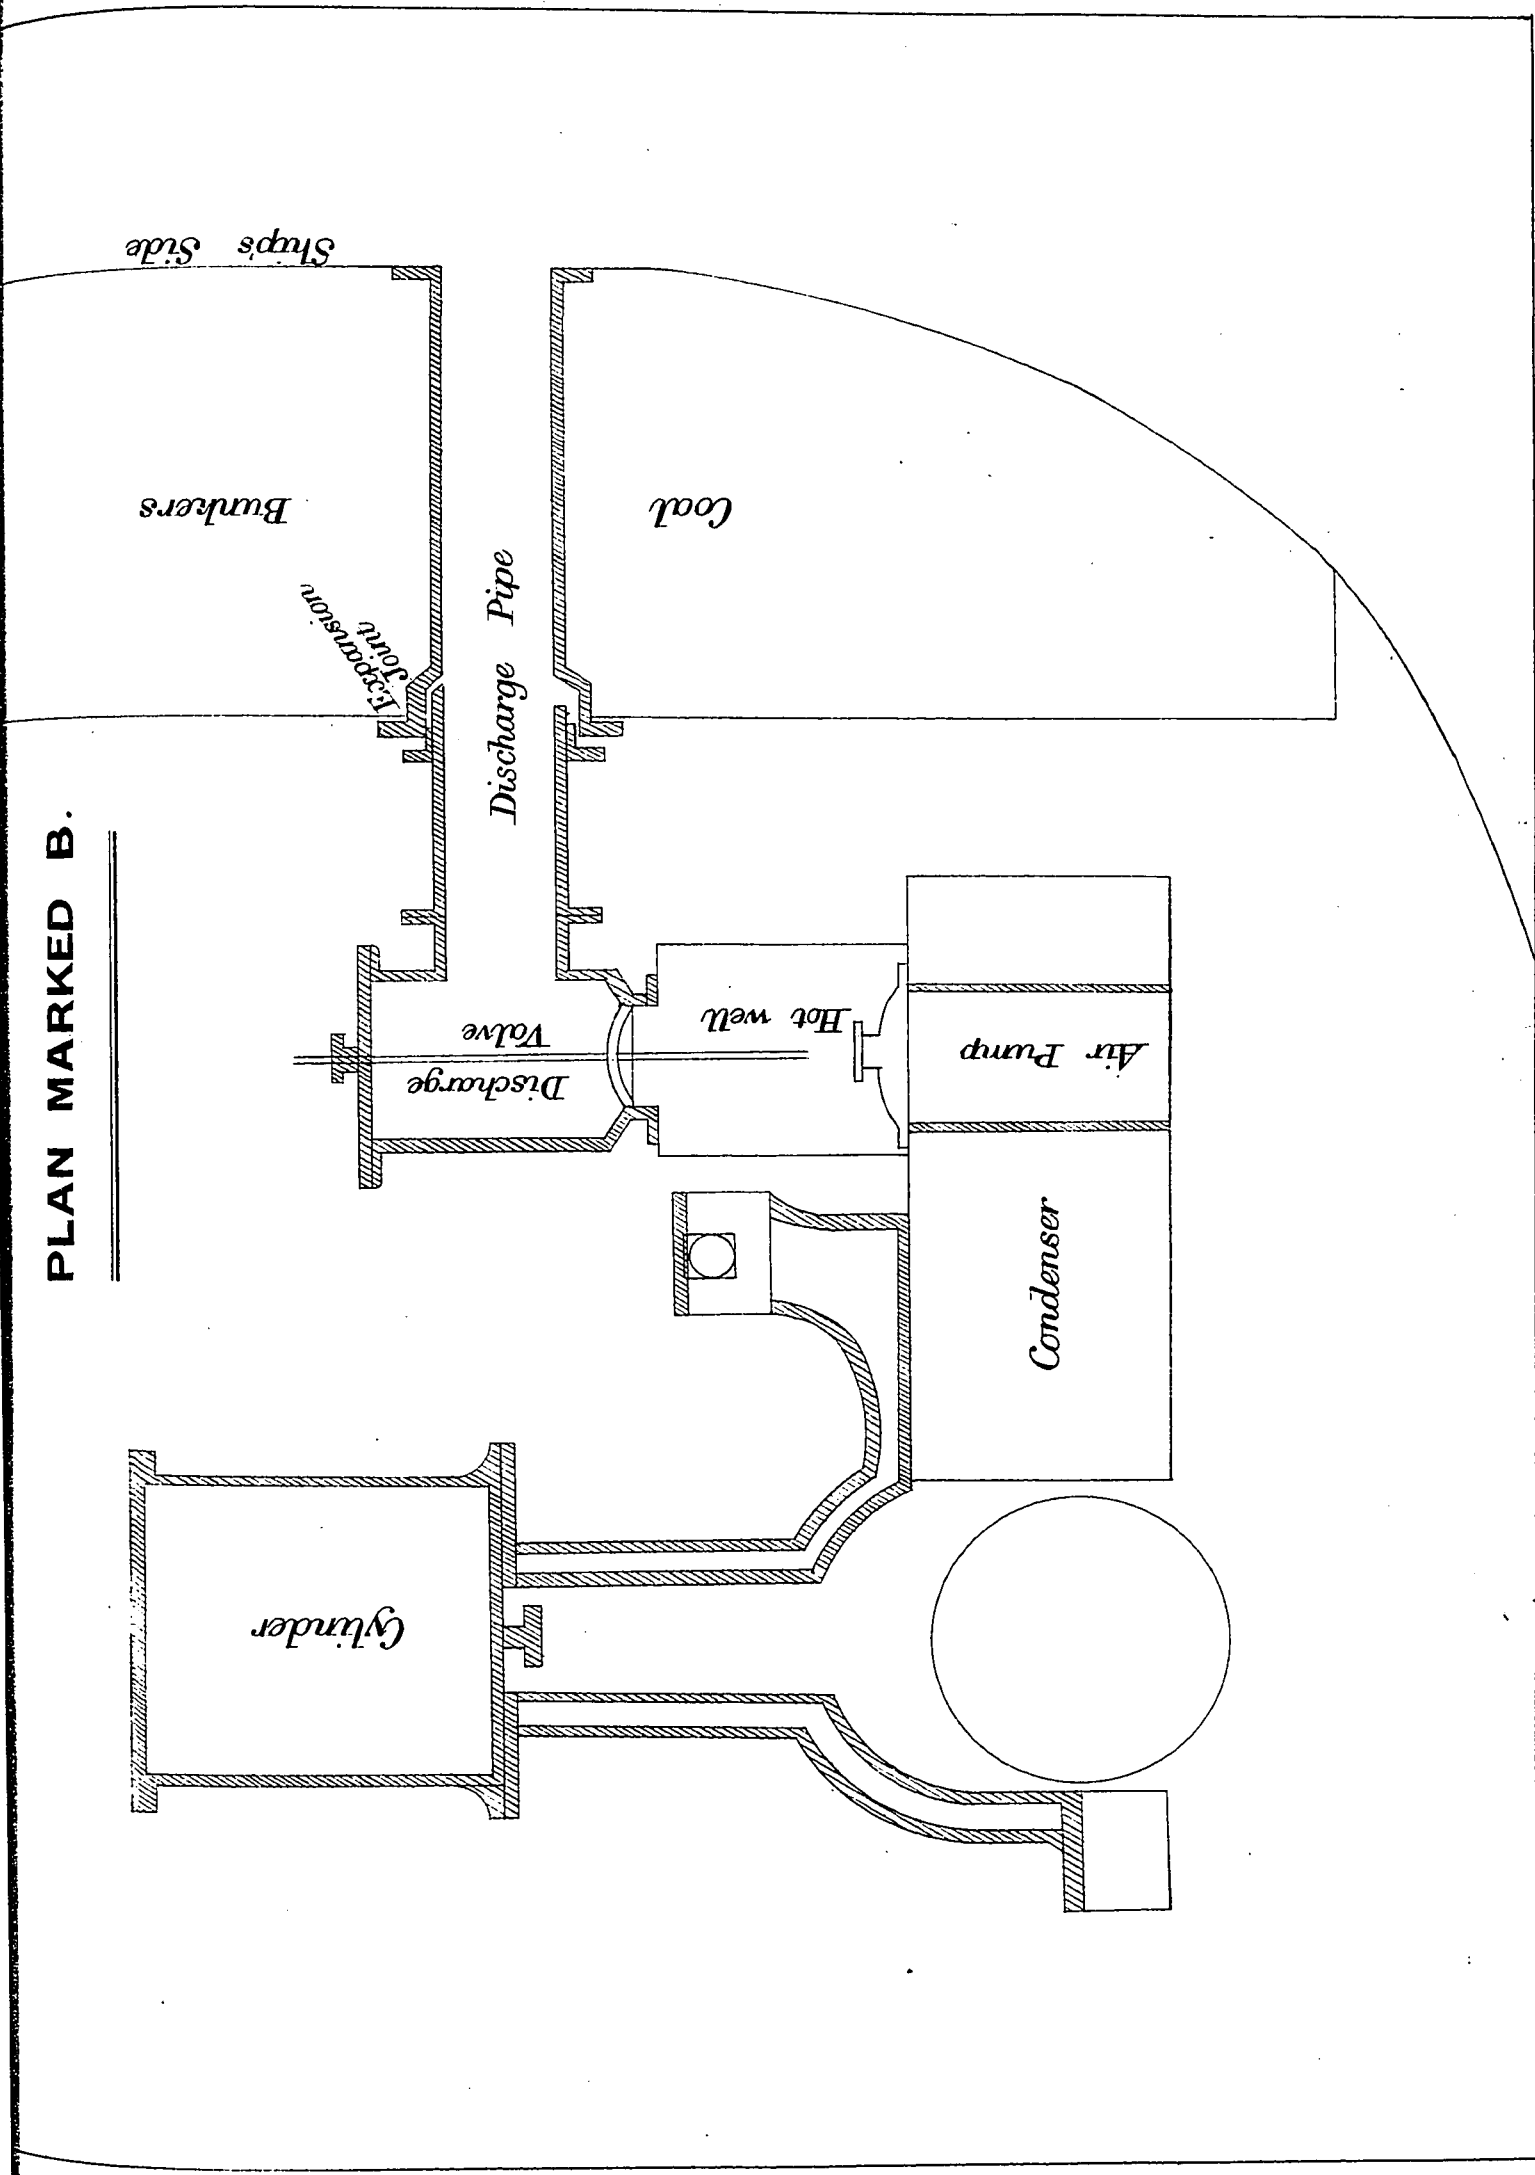
PLAN MARKED B.

2. That the cause of the loss of the vessel was the breaking of that part of the discharge pipe which was inside the port bunker, whereby the water was allowed to flow into the bunker, and thence into the ship.

were fairly constructed engines for the time at which they were made. A rough sketch of a part of the machinery, which was given in by the chief engineer, and which is annexed to this report, will help to explain the construction and arrangement in the immediate neighbourhood of the place where the water is stated to have come into the ship. It will be seen from this sketch and from the evidence of the witnesses who were examined before us, that close alongside the condenser, which was on the port side of the vessel, were two air pumps, immediately over which was the hot well, and above that the discharge valve. In a direct line from the discharge valve to the ship's side, and passing through the port bunker on its way, was the discharge pipe, which, according to Mr. Milner, was about 6 feet long, but according to Mr. Jacobs was somewhat longer. Where the pipe passed through the bunker frame there was an expansion joint, having a horizontal or lateral movement to allow for the expansion of the metal, but no vertical or up and down play to allow for the working of the ship. The top of the pipe, where it issued from the ship's side, was about 18 inches below the level of the load line; when then the vessel was light the mouth of the pipe would be well out of the water, but when she was loaded, seeing that she would then generally be brought down to the load line, the mouth of the pipe would be below the surface of the water, and the sea would consequently have free access to the pipe as far as the discharge valve. It will thus be seen that if, when the vessel was laden and the bunkers were full of coal, a fracture occurred in that part of the discharge pipe which was inside the bunker, the water would continue to run into the bunker, and that the shutting of the discharge valve, which was at the further end of the pipe and at least 6 feet from the vessel's side, would not stop the flow of water. And according to the chief engineer it was by the fracture of this part of the discharge pipe that the water had got into the ship.

also said that his attention was never specially directed to this pipe, and the only person who could give us any information about it was Mr. Milner, Mr. Jacobs' assistant, and the gentleman who had superintended the repairs at Hayle in 1878. According to Mr. Milner, the discharge pipe was of cast iron with a casing of wrought iron, and bound over on the outside with rope or spun yarn. He told us that he had looked through it, and that to his recollection it was not pitted or corroded, but he could not exactly remember what appearance it presented internally. He told us also that he went two or three times into the bunker and examined it externally; that he could see an inch or so of the casing at each end, and that from this he judged it to be of wrought iron, but that he had not had the rope or spun yarn removed, and that he knew nothing of the condition of the wrought-iron casing, whether it was water-tight or whether it fitted close to the pipe or not, nor could he tell us what was the external condition or the thickness of the cast-iron discharge pipe itself. Mr. Inskip indeed wished us to assume that the discharge pipe had been renewed when the engines were overhauled by Messrs. Dudgeon in 1873, but there is no evidence whatever of this. Messrs. Dudgeon's bill for the repairs done at that time was brought in, but although there were items relating to the discharge valve there was nothing to show that the discharge pipe had been renewed or even removed at that time, and the engines might easily have been taken out without disturbing the part of the discharge pipe which was inside the bunkers, owing to the expansion joint at the bunker frame. There is, therefore, nothing to show that this may not have been the very same pipe which was put into the vessel when she was originally built in 1858, nor have we any information as to when this wrought-iron casing and the rope were put round it, and whether they were intended to strengthen it or to protect it from the coal in the bunkers. Considering, however, that the interior of this discharge pipe was alternately exposed to the action of the sea water and of the air, according as the vessel was laden or light, and that we have no evidence whatever as to its condition or thickness, it certainly is not by any means improbable that it should have broken.

3. That not only should the discharge valve have been attached to the skin of the ship instead of being as it was at least 6 feet from the side, but that access should have been afforded to the discharge pipe along its own length, so that in the event of a fracture in the pipe means might have been at once adopted to prevent the influx of the water.
