"SILVERLIP" (S.S.).

The Merchant Shipping Act, 1894.

REPORT to the Board of Trade on the circumstances attending an explosion and fire which caused the death of five persons and injury to several others, together with the loss of the vessel, and which occurred on the tank steamship "SILVERLIP," in the Bay of Biscay, on the 1st day of May, 1907.

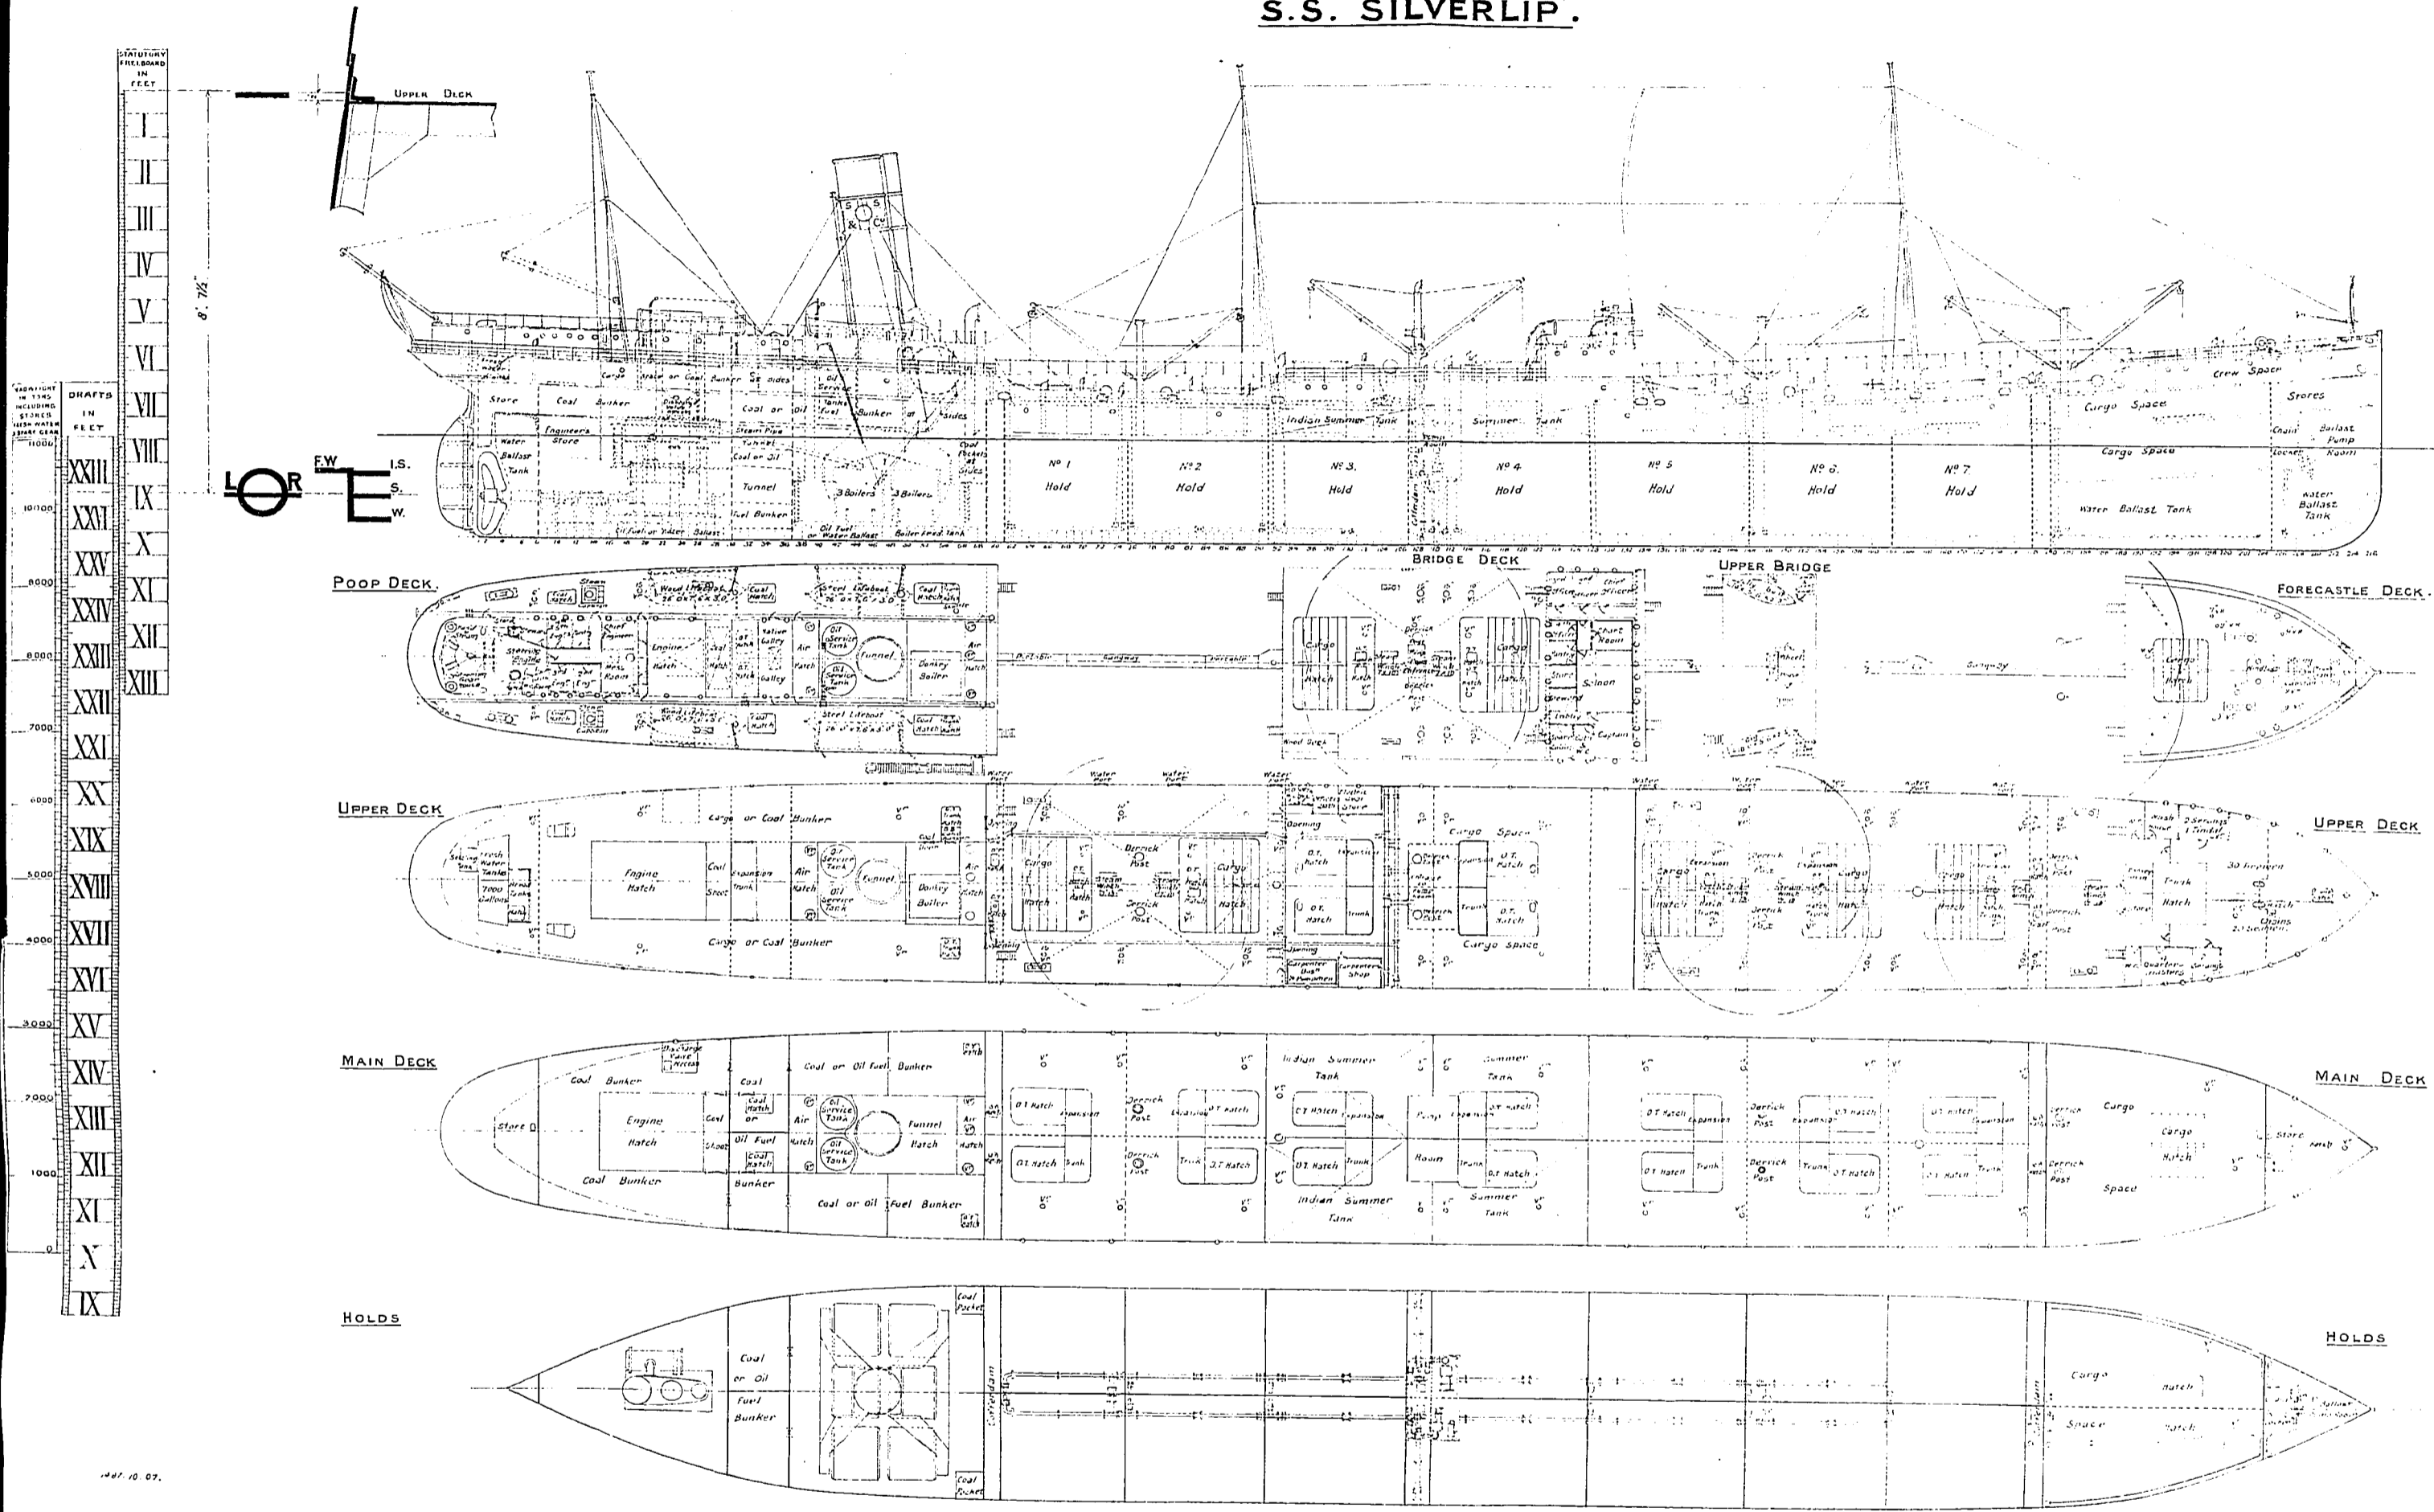
HALF MIDSHIP SECTION.

# S.S. "SILVERLIP".

The "Silverlip" was a steel tank steamship, built at Low Walker, on the Tyne, by Sir William Armstrong, Whitworth & Company, Limited, in the year 1903. Her length was 470 feet, her breadth 55 feet, and her depth 33 feet. She was rigged as a schooner and fitted with triple expansion engines of 586 horsepower, calculated to propel the vessel at a speed of 11 knots per hour. Her tonnage, after deducting 2589 tons for propelling power and crew space, was 4904 tons. She was registered in London, her official number being 118327, and was classed 100 A1.
